MIDLAND STANDARD ENGINEERING & TESTING, INC.

Re: **Pavement Rehabilitation**
McHenry County College – Parking Lot C
MSET File No. 19671

PAVEMENT CORE MEASUREMENT LOG
McHENRY COUNTY COLLEGE - PARKING LOT C
CRYSTAL LAKE, ILLINOIS

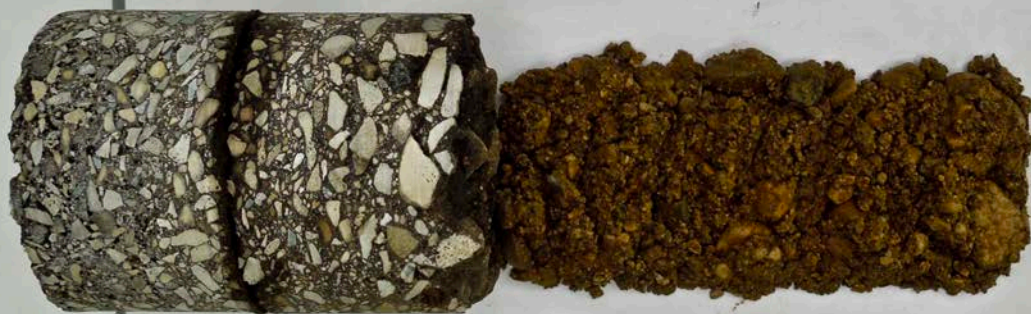
Core No. C-1							
Location	Parking Lot C - 974527E, 2037472N						
Material	Depth (in.)		Thickness (in.)		Remarks/Condition	coeff	sn
Bituminous Surface	0	to 2- 1/2	2- 1/2			0.30	0.75
Crack Control Fabric						0.00	0.00
Bituminous Surface	2- 1/2	to 4	1- 1/2			0.23	0.35
Bituminous Binder	4	to 5- 1/2	1- 1/2			0.20	0.30
Granular Base Course	5- 1/2	to 13- 1/2	8		Brown SAND and Gravel	0.10	0.80
Subgrade	13- 1/2				Brownish-Grey Lean CLAY, CL		2.20
						Mc=26%, IBV=13, Qu=4.1 tsf	
Core No. C-2							
Location	Parking Lot C - 974748E, 2037496N						
Material	Depth (in)		Thickness (in.)		Remarks/ Condition	coeff	sn
Bituminous Surface	0	to 1- 3/4	1- 3/4			0.30	0.53
Crack Control Fabric						0.00	0.00
Bituminous Surface	1- 3/4	to 3	1- 1/4			0.23	0.29
Bituminous Binder	3	to 4	1			0.20	0.20
Granular Base Course	4	to 10	6		Brown SAND and Gravel	0.10	0.60
Granular Base Course	10	to 14- 1/2	4- 1/2		Brown Clayey SAND and Gravel, SC	0.00	0.00

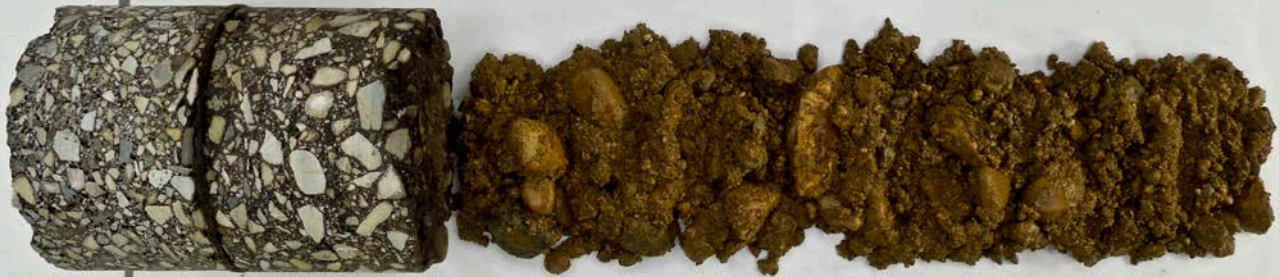
Granular Base Course	14- 1/2	to 20	5- 1/2		Brown SAND and Gravel, some Cobbles	0.10	0.55
Auger Refusal at 20"							2.16
Core No. C-3							
Location	Parking Lot C - 974892E, 2037381N						
Material	Depth (in.)		Thickness (in.)		Remarks/Condition	coeff	sn
Bituminous Surface	0	to 2- 1/2	2- 1/2			0.30	0.75
Crack Control Fabric						0.00	0.00
Bituminous Surface	2- 1/2	to 3- 3/4	1- 1/4			0.23	0.29
Bituminous Binder	3- 3/4	to 5- 1/2	1- 3/4			0.20	0.35
Granular Base Course	5- 1/2	to 20	14- 1/2		Brown SAND and Gravel, some Cobbles	0.10	1.45
Auger Refusal at 20"							2.84
Core No. C-4							
Location	Parking Lot C - 974594E, 2037369N						
Material	Depth (in.)		Thickness (in.)		Remarks/Condition	coeff	sn
Bituminous Surface	0	to 2	2			0.30	0.60
Crack Control Fabric						0.00	0.00
Bituminous Surface	2	to 3- 1/2	1- 1/2			0.23	0.35
Bituminous Binder	3- 1/2	to 4- 3/4	1- 1/4			0.20	0.25
Granular Base Course	4- 3/4	to 8- 1/2	3- 3/4		Brown SAND and Gravel	0.10	0.38

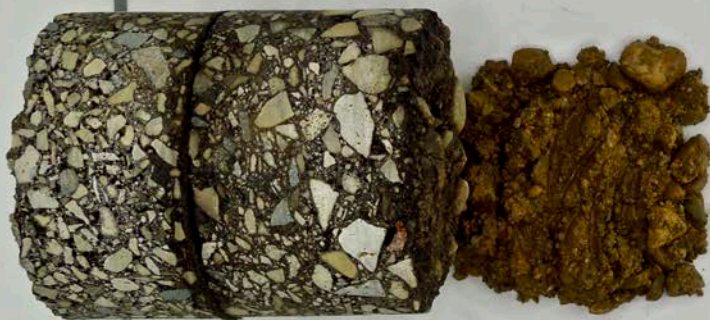
C-4

Subgrade	8- 1/2				Grey, some Brown Lean CLAY, CL		1.57
						Mc=18%, IBV=7.2, Qu=2.3 tsf
